BEYOND MISINFORMATION

What Science Says About the Destruction of
World Trade Center Buildings 1, 2, and 7

ARCHITECTS
& ENGINEERS
for 9/11 TRUTH

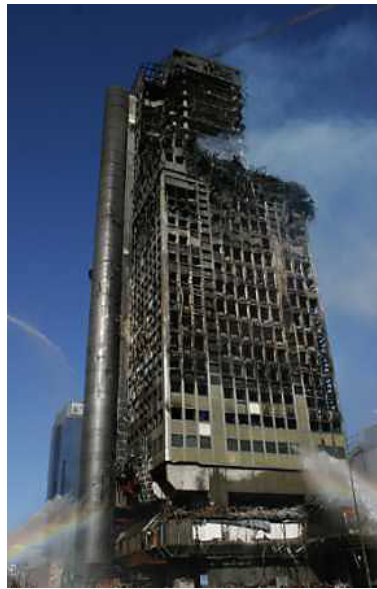
The Windsor Tower after having burned for almost 24 hours.

stages over several hours, of floors where the steel support columns and beams had no fire protection. In 2008, the 13-story Delft University Faculty of Architecture Building in the Netherlands, constructed of reinforced concrete, burned for seven hours and experienced a partial collapse of a 13-story section of the building. Yet there remains no documented instance of a steel-framed high-rise building suffering total collapse from fire, and only a small number have experienced partial collapse.

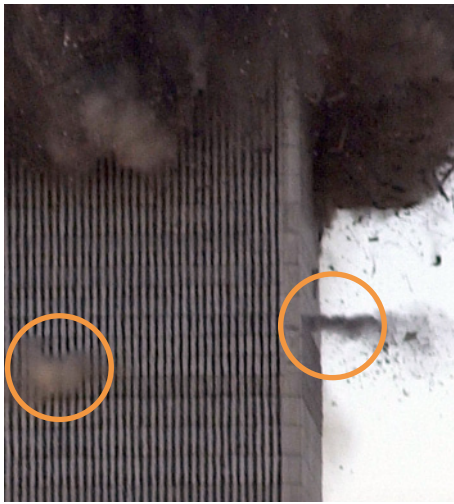
High-velocity bursts of debris, or “squibs,” being ejected from point-like sources in WTC 1 and WTC 2, as many as 20 to 30 stories below the collapse front.

- The floors were not the kind of tightly sealed, highly pressurized containers that would be required to generate overpressures strong enough to burst windows.
- The falling mass would need to act as a flat plate exerting uniform pressure at all points. But the falling upper sections, themselves disintegrating as observed in the videos,

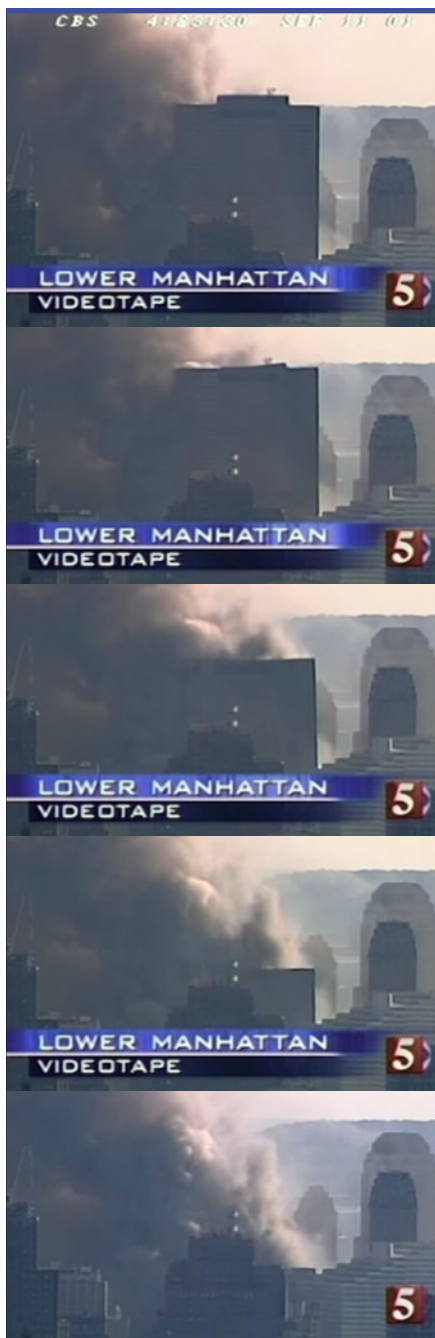
WTC 7 is shown falling symmetrically into its own footprint. It accelerated at free fall for 2.25 seconds of its descent.

Today, NIST acknowledges that WTC 7 fell at a rate of free fall (or the rate of gravity) for a period of approximately 2.25 seconds before it started to

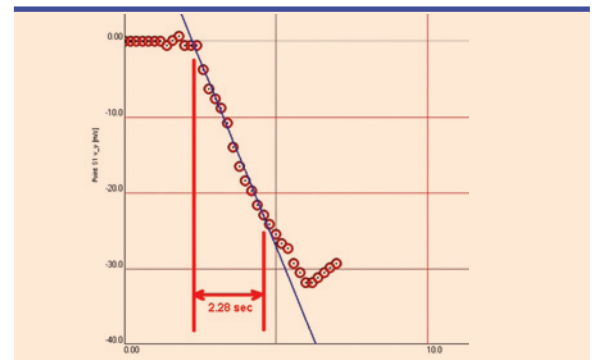
David Chandler's graph from Part 3 of NIST Finally Admits Free Fall plots the velocity of WTC 7's roofline versus time. The slope shows a free-fall rate of acceleration. The sudden change in slope shows the sudden onset of free fall.
